Photographic record of a Martial Eagle killed at Jeffreys Bay wind farm

Rob Simmons, Marlei Martins

July 2016

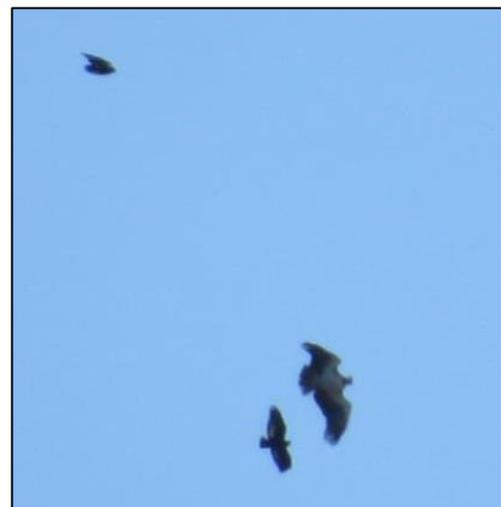
At 10:19 two Jackal Buzzards *Buteo rufofuscus* were observed persistently mobbing the Martial Eagle over turbines 38 and 39 at a height of about 150 m. The mobbing continued for 11 minutes until 10:30 when the remaining buzzard headed north west. Their persistence had forced the eagle to a lower altitude of about 120-130m and she began circling around turbine 38 in medium-strength north-

westerly winds (between 10.9 and 11.4 km h⁻¹) under clear skies.

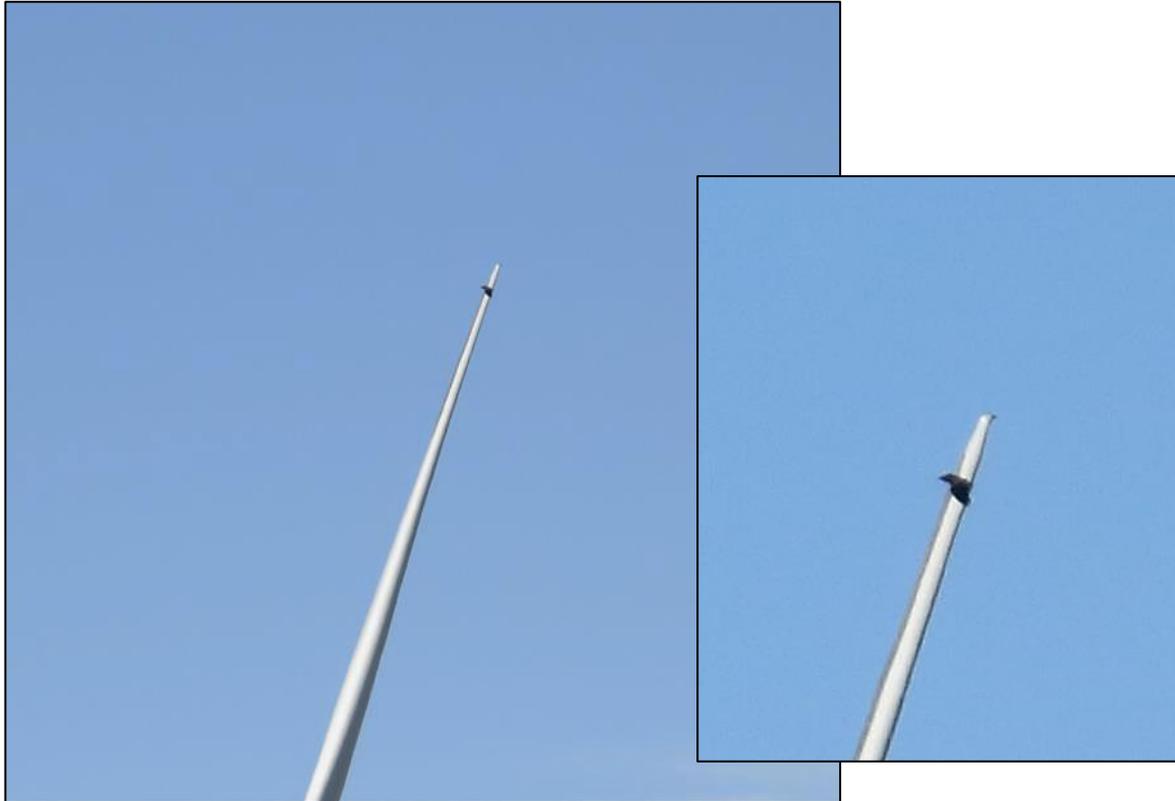
At 10:30 the eagle began soaring to regain height over turbine 38, in the absence of the buzzards. As she moved in a westerly direction (right to left in the images below) a turbine blade hit her on her right flank as it reached the highest point of its arc. The impact shown below occurred approximately 1-2 m from the end of the 49 m blade.

She appeared to turn as if she saw the blade approaching from her right. Blades tips of these turbines travel at a near constant speed of 323 km h⁻¹ except in the lightest winds (P Oosthuizen pers comm) and it would have been difficult for her to avoid it.

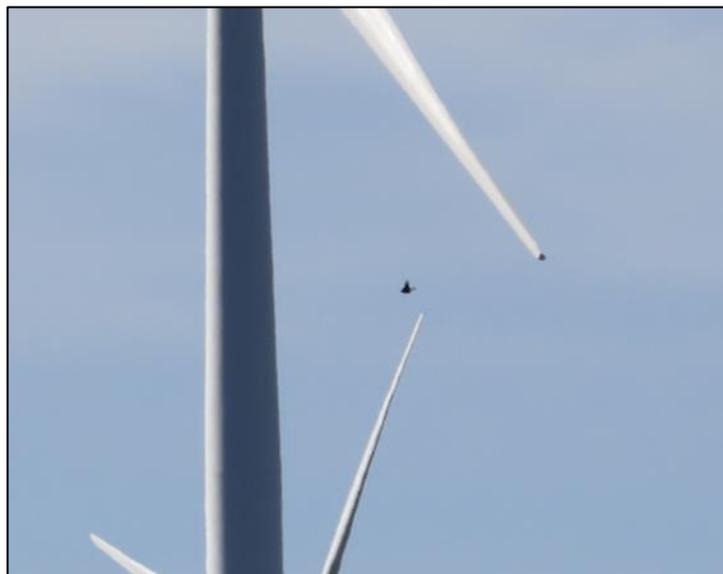
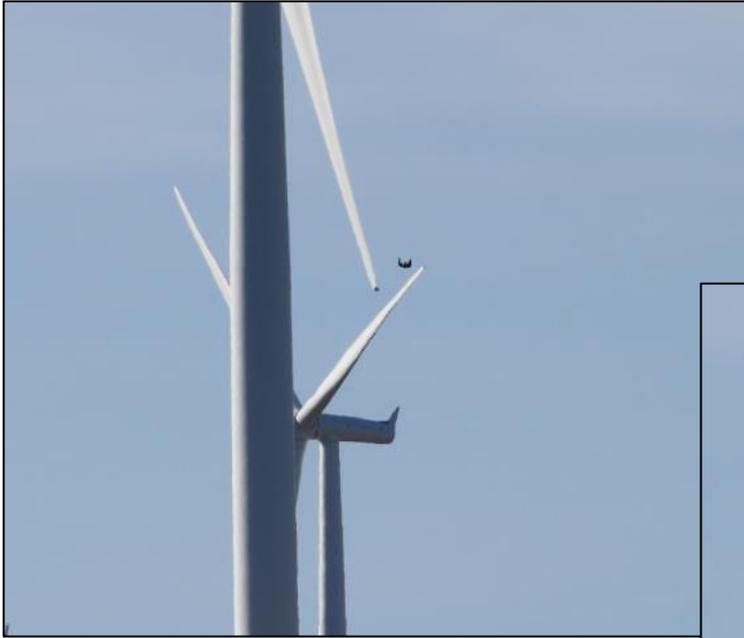
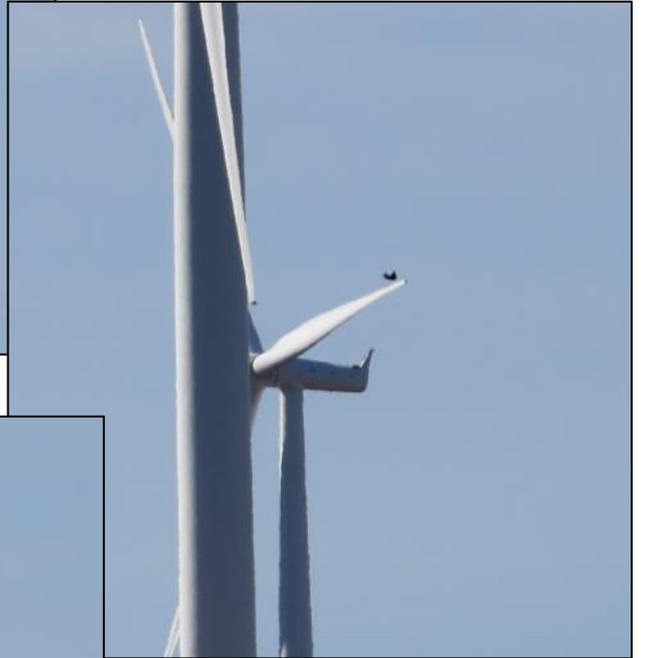
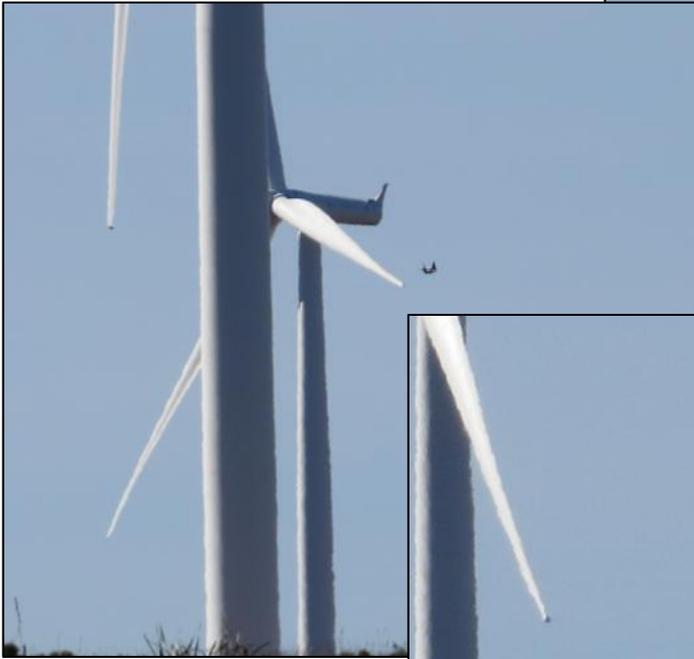
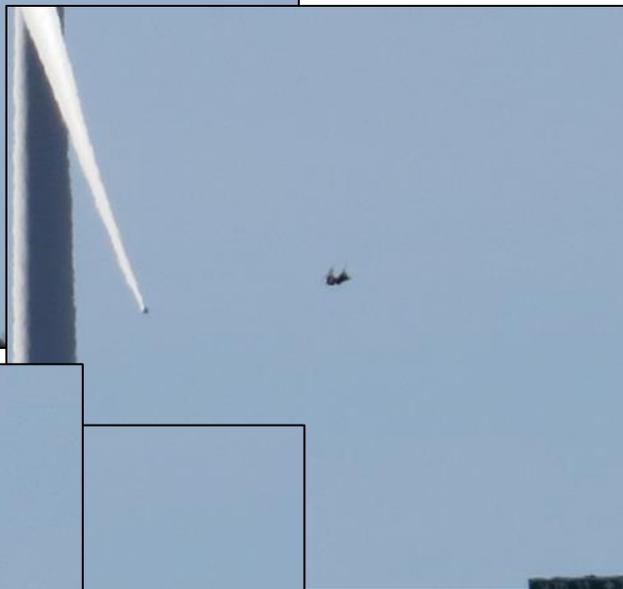
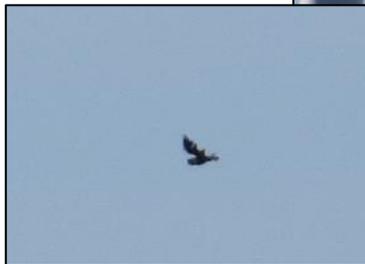
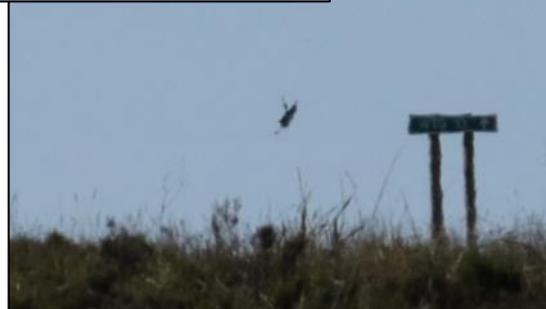
First visual observations from 990 m away suggested it had missed her and she was flying away. However, she plummeted vertically from about 80 m above the ground (the hub height), to hit the ground 35 m from the base of the turbine.

The following sequence of photographs, taken with the rapid-sequence function on a Canon Power shot SX50 SD digital camera shows the whole descent to the ground from ~60 m at 10:30.

Photos: The subadult Martial Eagle free-falling from ~50m following the turbine blade strike at Jeffreys Bay wind farm on 27 July.

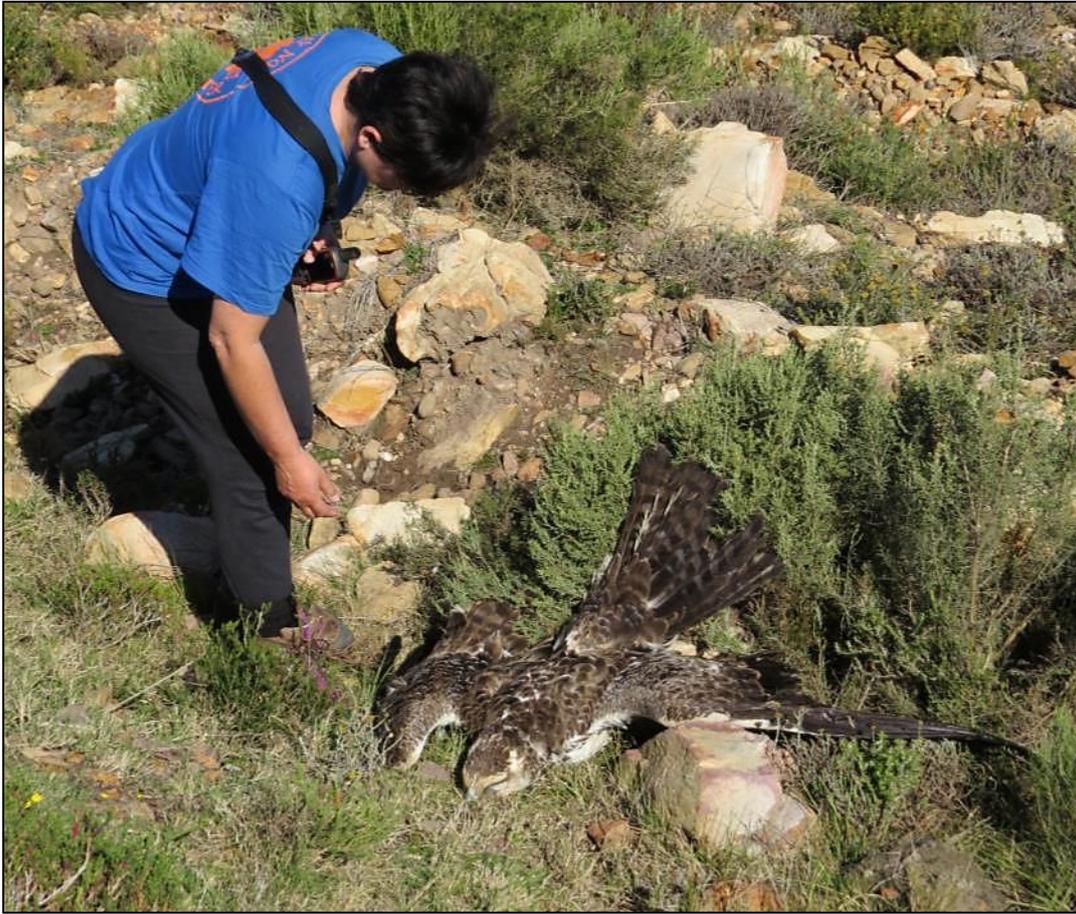
She appeared to fall earthwards on her back, judging by the photographs, but was face-down when first found (above).

We initially mistook the turbine that had impacted her (it is the closer of the two in the photographs above) and we only recovered her body at 13:22, about 3h after she was killed. She was 35 m from the base in the position shown, on the south side of the turbine, at S 34 01' 05.4" E 24 50' 05.4".

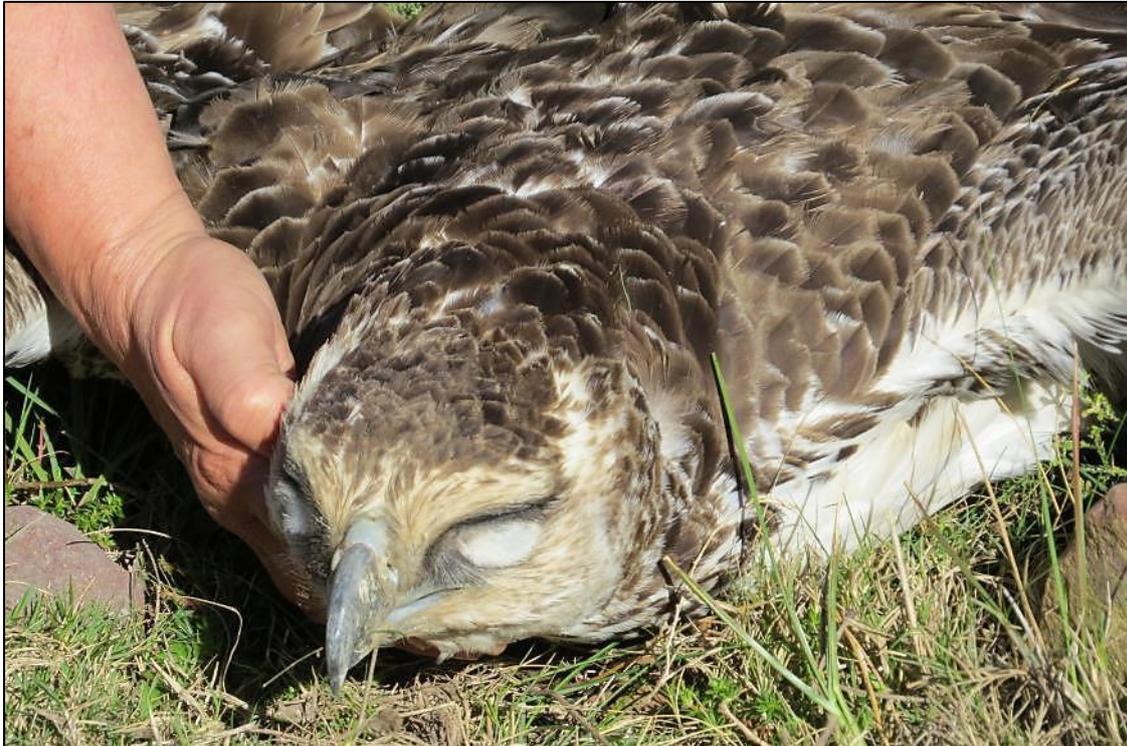
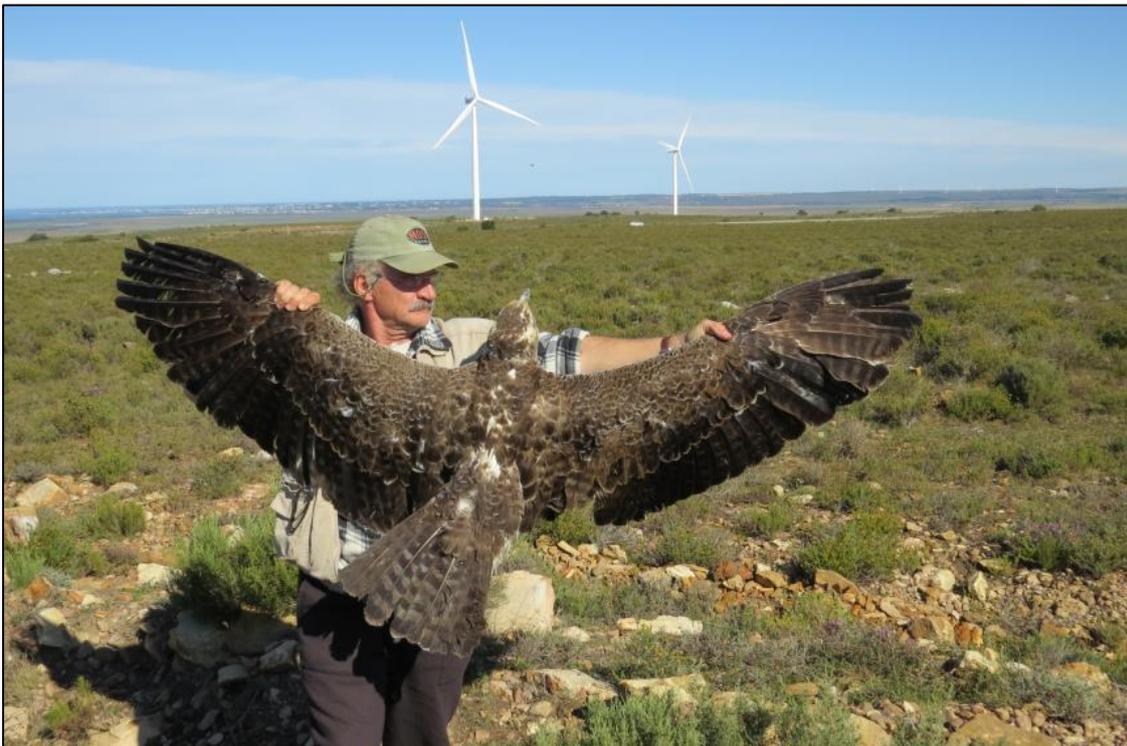
Photos 3 and 4: The large size of the bird and a mass of 5.1 kg suggested a female.

The size of the subadult bird suggested it was a female, with a mass of 5.1 kg (Simmons 2005). She was aged by her plumage to be a 3rd year bird, two years from adulthood (R van Eeden pers. comm.). The sternum and breast muscle suggested she was in good condition, a conclusion supported by veterinarian, Dr Glanville. All other signs were that she was a healthy bird with no stress bars in the feathers, and no obvious feather parasites.

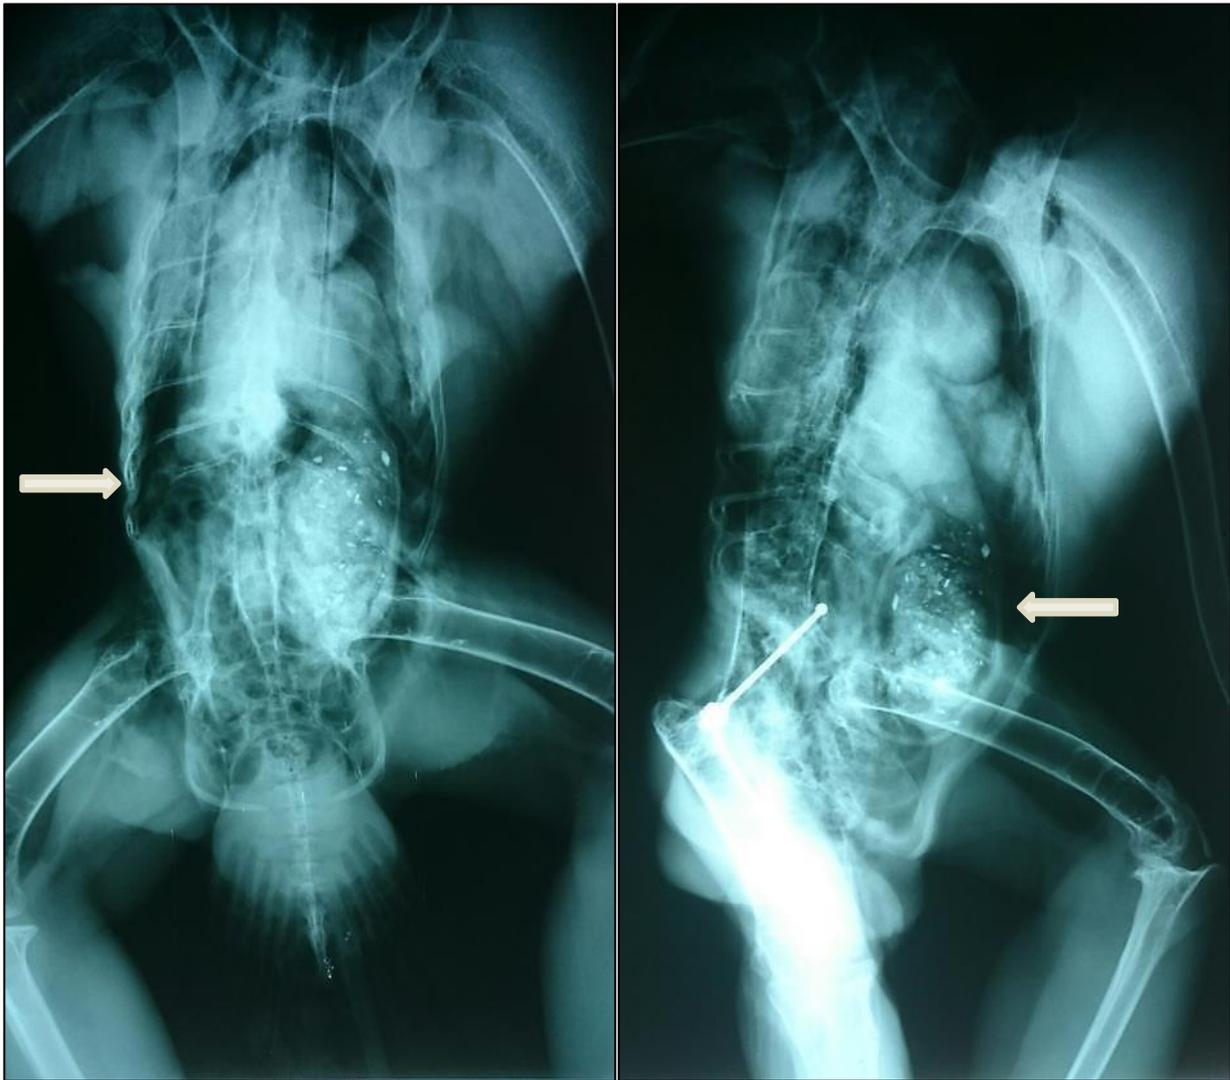
The X-rays indicated the break in her back, (Figure 1), and it was possible to feel the breakage in her vertebrae through the gash in her side. The gash was approximately 5 cm x 3 cm, and had penetrated the abdominal cavity.

Figure 1: X-rays of the subadult Martial Eagle killed by impact with a turbine blade. The left image showing a dorsal view indicates the gash (lower left abdomen) and the misaligned vertebrae. A lateral view (right) shows a pin inserted into the gash to indicate its position. Note the full but ruptured, stomach with white flecks (presumed to be bone from prey) and the muscle mass present around the femur and tibio- tarsus.

First impressions suggested no external injuries other than a broken left foot. However, subsequent post-mortem examination at the veterinary clinic of Dr D Glanville in Jeffreys Bay indicated the extent of her injuries. These included a broken lower spine and a gash in her right flank just above her right thigh (Appendix). Given the break in her central-lower spine it is likely that she was dead or paralysed by the time she hit the ground. Her broken left foot, with no obvious haemorrhaging, suggests it was broken as she hit a small rock on the ground on impact.

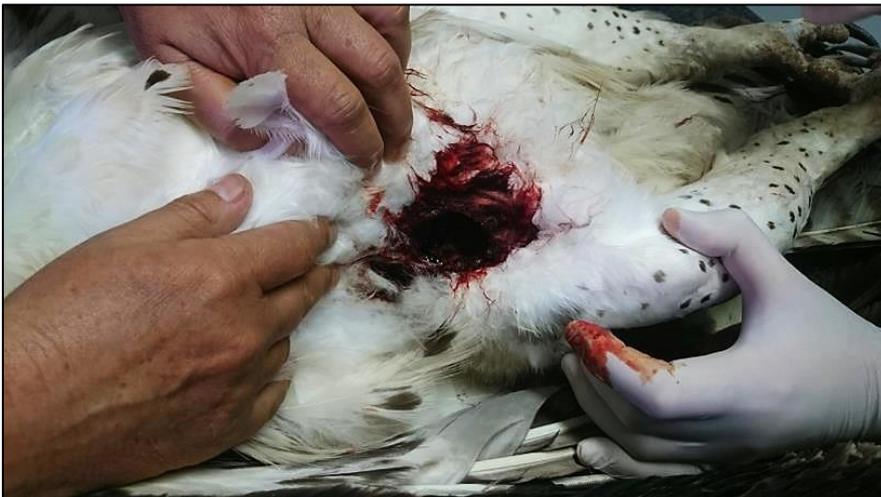
(Top) The small gash in the Martial eagle's lower right abdomen, which punctured the abdominal wall. Minimal bleeding was apparent from this wound.

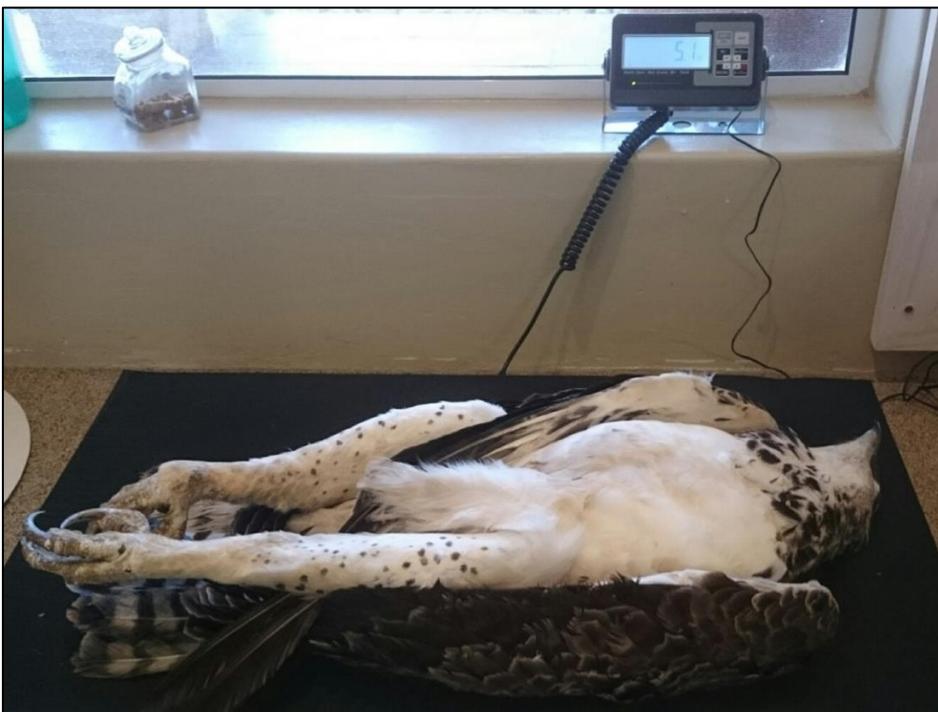
(Bottom) The eagle weighed on a veterinary scale, indicating a healthy mass of 5.1 kg
